**Vista Pointe Townhome Association  
4007 E. Geddes Circle  
Centennial, CO 80122**

**Level 1 Reserve Analysis**

**Report Period – 01/01/14 – 12/31/14**

**Client Reference Number - 8682  
Property Type – Townhomes  
Number of Units – 47  
Fiscal Year End – December 31**

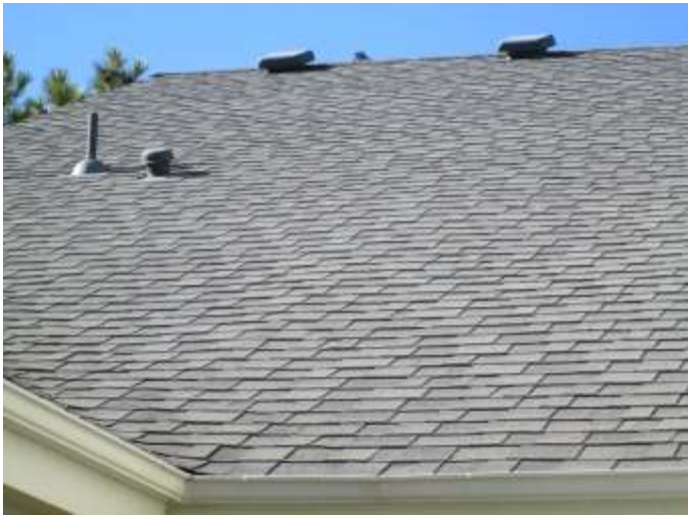
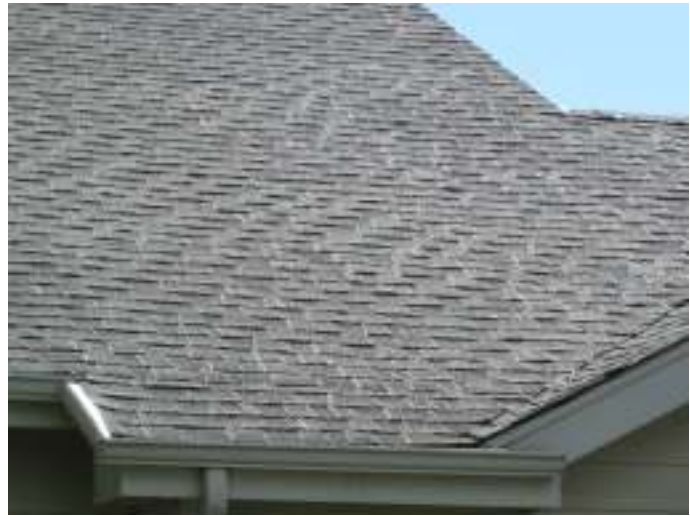
Comp #: 105 Comp Shingle Roof - Replace

The community was hit by a hail storm in 2012, but there was not enough significant damage to warrant an insurance claim. It was reported there was about \$10,000 in needed repairs, but this did not extend the current life expectancy. According to a local contractor, the roofs have about 4 - 5 years left before replacement is necessary. It was also reported that the roof wasn't properly flashed in the first place. While a roof is rated as a "30-year" shingle, replacement typically needs to occur within 15 - 20 years due to weather elements such as hail, wind, and temperature fluctuations. Reserve funding includes complete tearoff and replacement.

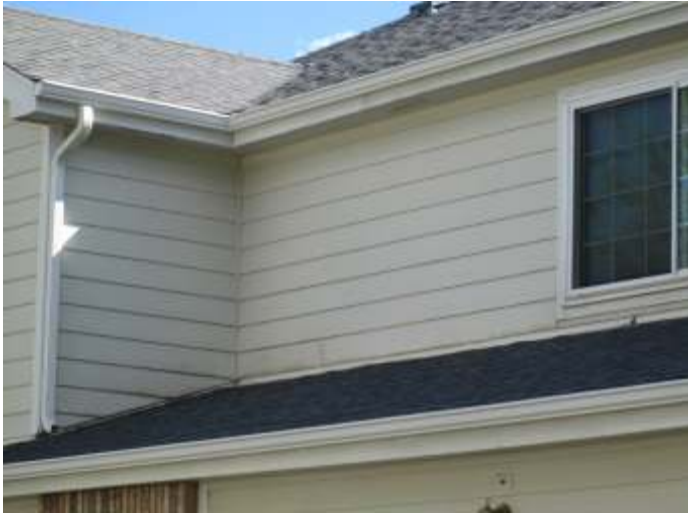
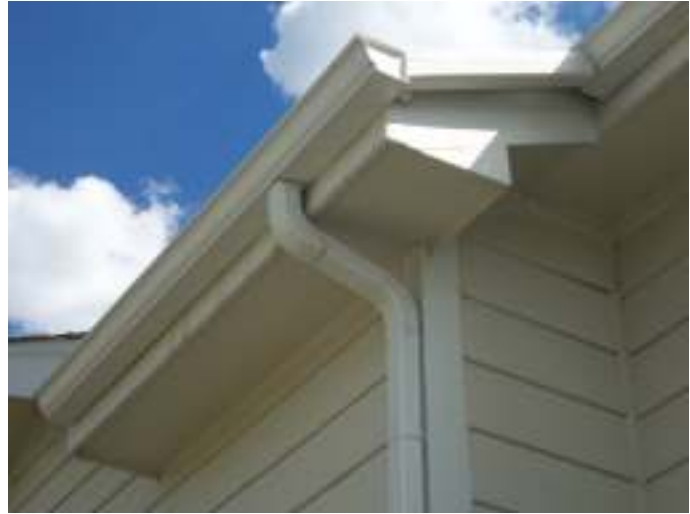
Comp #: 120 Gutters/Downspouts - Replace

It was reported that new rain gutters were recently installed along the top tier that faces the driveways. This area is not significant enough to separate from the rest of the gutters and downspouts. The rest of the materials are original and nearing the end of their typical life expectancy. The life expectancy for gutters and downspouts ranges between 20 - 25 years, depending on maintenance. Keep gutters and downspouts free from debris which can cause corrosion of metal materials or blockage which can cause the downspouts to freeze and expand during winter months. Expect to replace at same time as roof replacement.

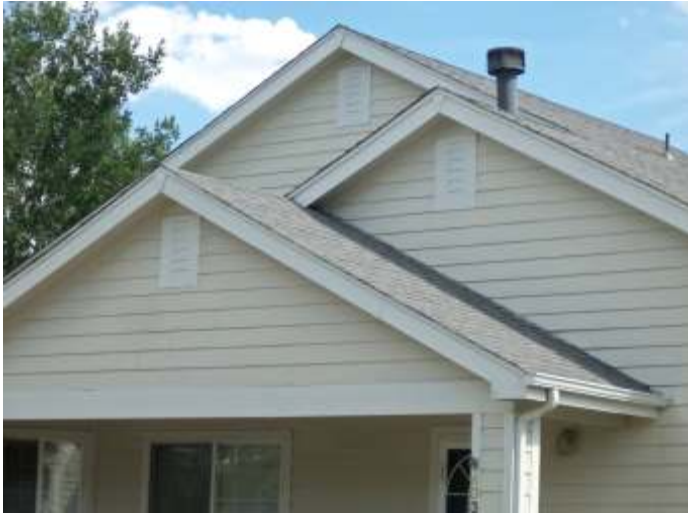
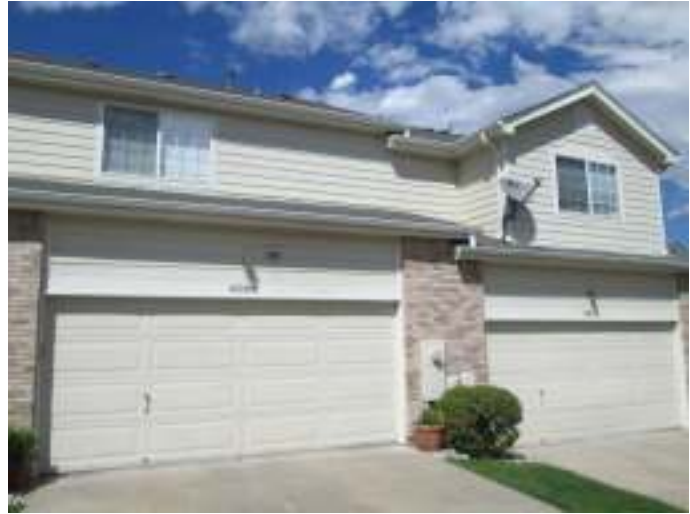
Comp #:    204    Building Ext Surfaces - Repaint

Association has been performing touch ups throughout every year and completely repainted the patio walls and the garage trim in 2012. It was reported another \$5,000 was going to be spent in 2013 on various touch ups. The last time the entire community was repainted was about 8 - 9 years ago. With the reported need for major touch ups for the past several years, it follows our recommendation that building exterior surfaces typically need to be repainted every 4 - 6 years in this climate. Therefore, we have established a repainting cycle of every 6 years based on past experience for this community.

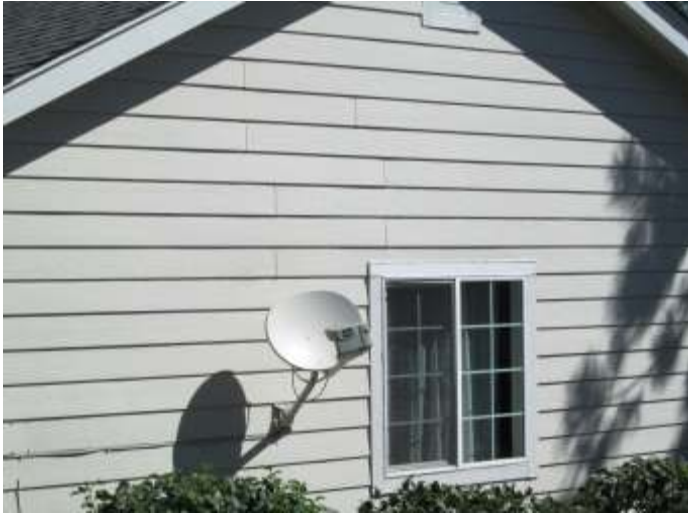
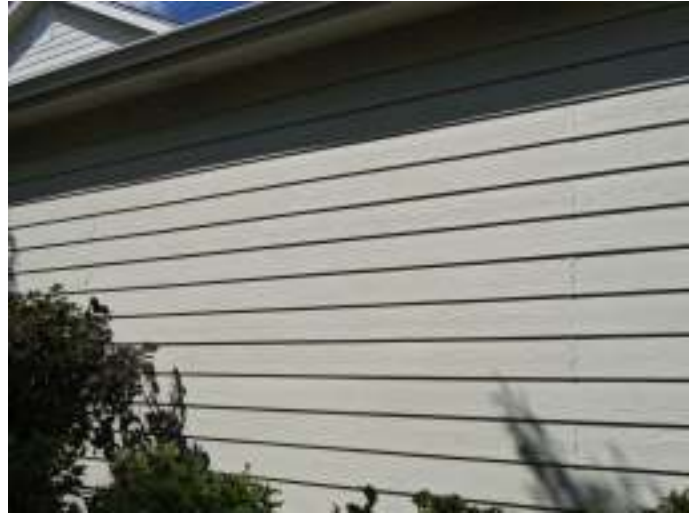
Comp #: 301 Hardboard Siding - Major Repairs

Siding materials are in good condition, considering the age of the community. As the property ages, siding tends to warp and deteriorate to a point where repairs are required. We suggest establishing Reserve funds for major repairs every other painting cycle. The remaining life is based on the observed conditions at the time of our site evaluation.

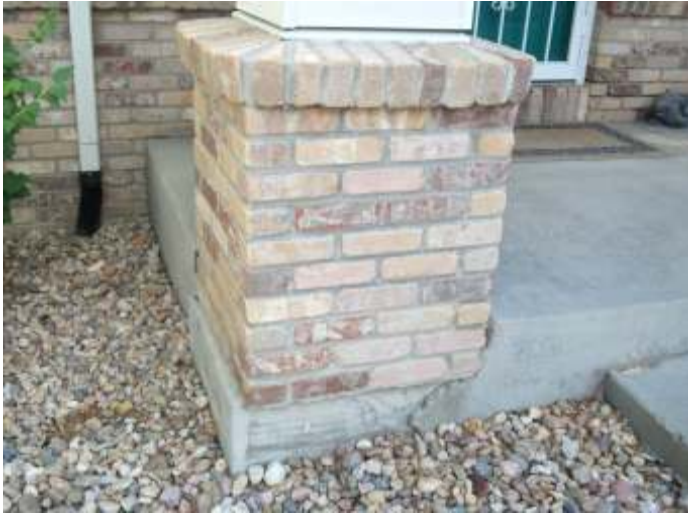
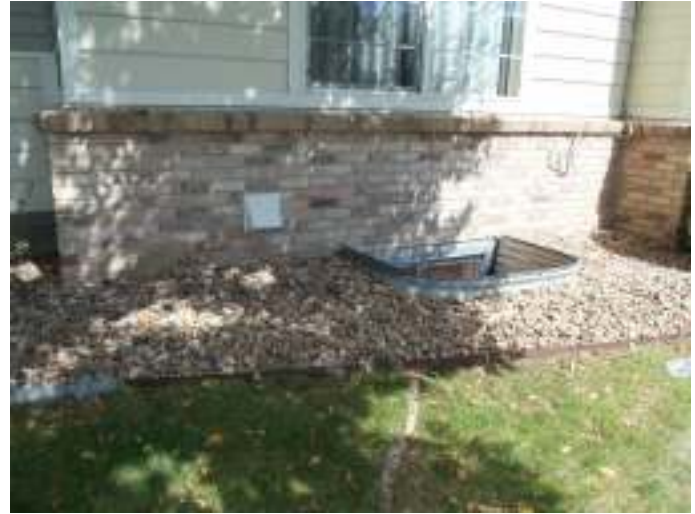
Comp #: 306 Brick - Replace

Bricks appeared to be attached to the sides of the building well with no loose or missing material noted. Typically, bricks have an extended life expectancy and complete replacement is unlikely. There are times where minor repairs may become necessary, but this is unpredictable when and how much would occur. Repairs should be handled as a maintenance issue on an as needed basis. Reserve funding is not required for this component at this time. If it later turns out that frequent repairs are necessary, then funding could be added in future Reserve Study updates.

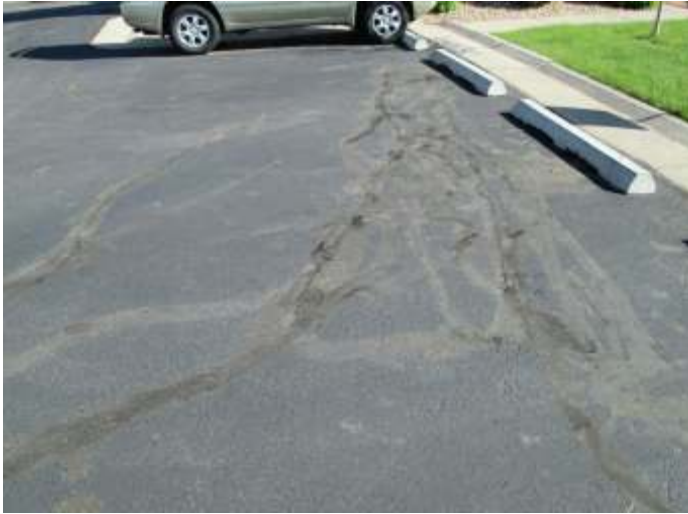
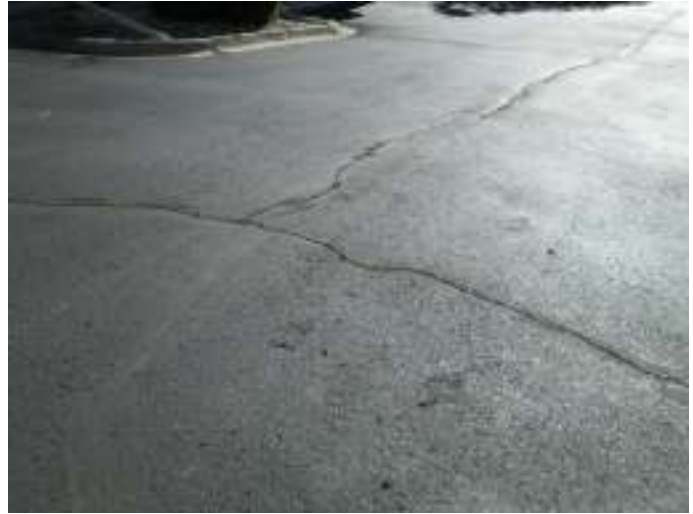
Comp #: 401 Asphalt - Overlay

In general, the overall integrity of the asphalt is in fair condition with some signs of major cracks, but no substantial settling or potholes developing as of the day of our site visit. The average life expectancy for asphalt surfaces ranges between 20 - 27 years for surfaces that are maintained on a regular schedule. Maintenance includes crack fill and repairing small potholes annually as an operating expense. In addition, asphalt should be seal coated every 2 - 4 years, depending on the level of traffic and snow removing techniques.

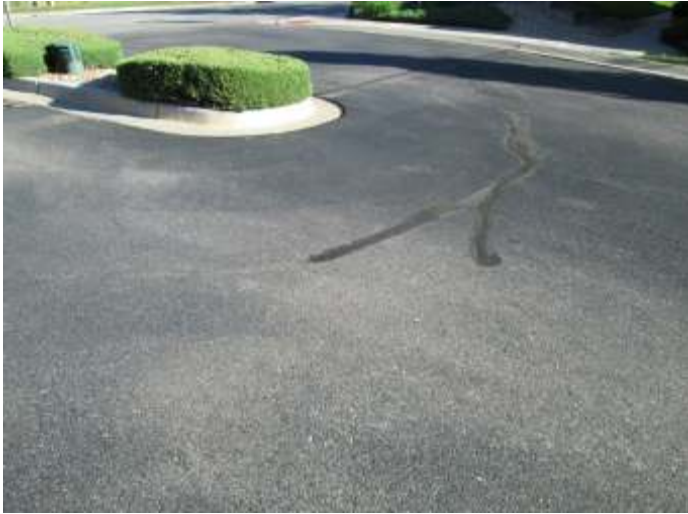
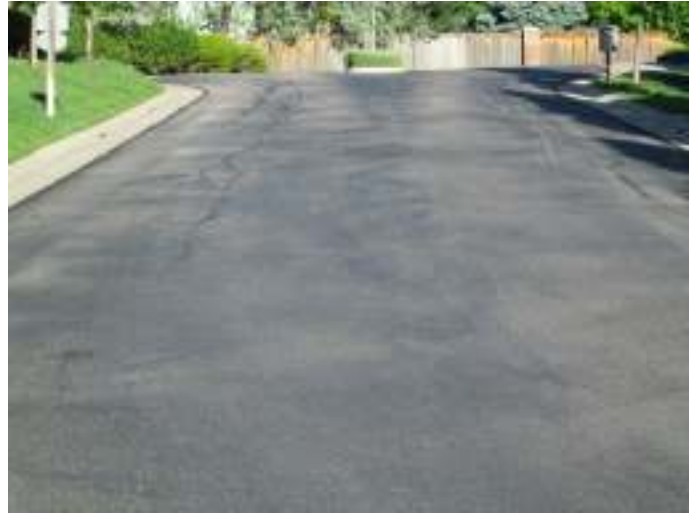
Comp #: 402 Asphalt - Seal Coat/crack fill

It was reported the streets were last seal coated in 2011. At the time of our field evaluation, we noted some dry areas, and minimal cracking. These are typical conditions for surfaces that were last sealed about 2 - 3 years ago. This type of material is subject to heavy wear in this environment due to snow removal techniques. Snow plows gradually remove small layers of asphalt every time plows are used. Sand and gravel acts as sand paper to the surface as cars drive over the surface. No matter what kind of removal is used, the asphalt layers diminish each year. In this environment, it is recommended that a seal coat is applied every 2 - 3 years, depending on the amount of traffic and the effects of the elements over the years.

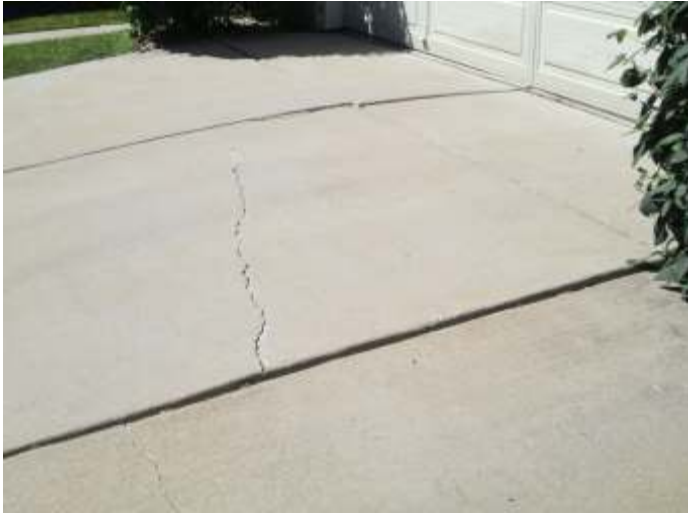
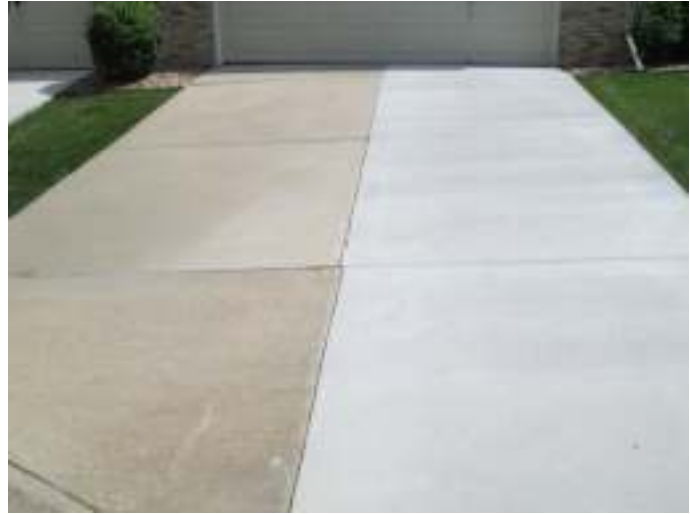
Comp #: 403 Concrete - Repair/Replace

4015/4021 needs to be replaced as there are extensive signs of separation at expansion joints. Approximately 450 GSF of building 4024/4018 was recently replaced. Reported \$2,000 is budgeted each year for concrete repairs. However, based on the total square footage of concrete (combined with sidewalks), we do not believe this is adequate for long term repairs for concrete. Therefore, we have included an allowance for periodic major repairs above and beyond what the association is already budgeting for in the operating account.

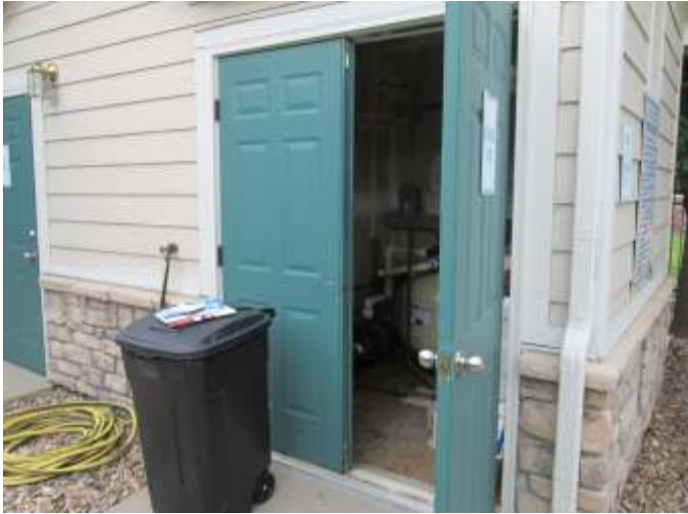
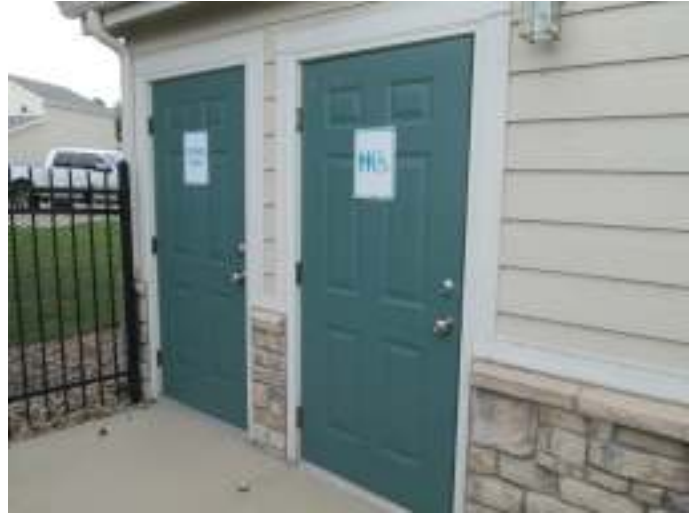
Comp #: 501 Doors - Replace

No unusual conditions noted or reported with doors at time of field evaluation. These doors, along with all pool area components, are shared with the neighboring association. Therefore, it makes the replacement cost for this association too small for separate Reserve designation. Replace individually as needed with general maintenance funds.

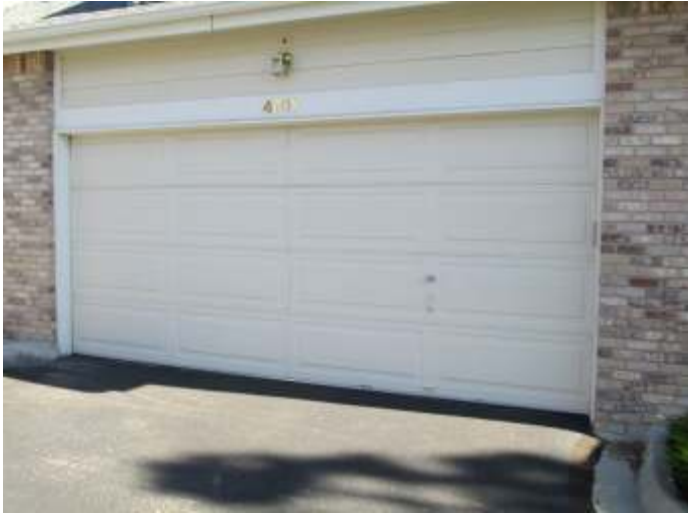
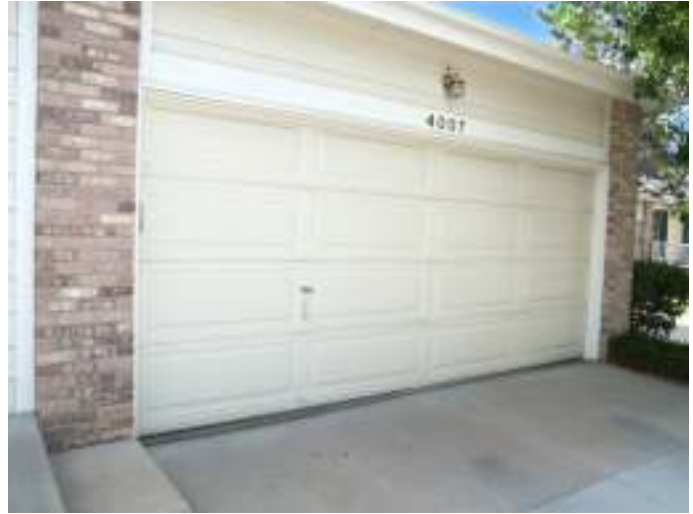
Comp #: 502 Garage Doors - Replace

No major problems observed with the garage doors at the time of inspection. Under section 4.4 of the declarations, the vertical perimeter boundaries of the are determined to be the exterior surface of doors. Therefore, at this time, Reserve funding is not required for this component. Some associations decide to take on the responsibility as an HOA expense in order to maintain a consistent appearance and to obtain the best replacement cost possible.

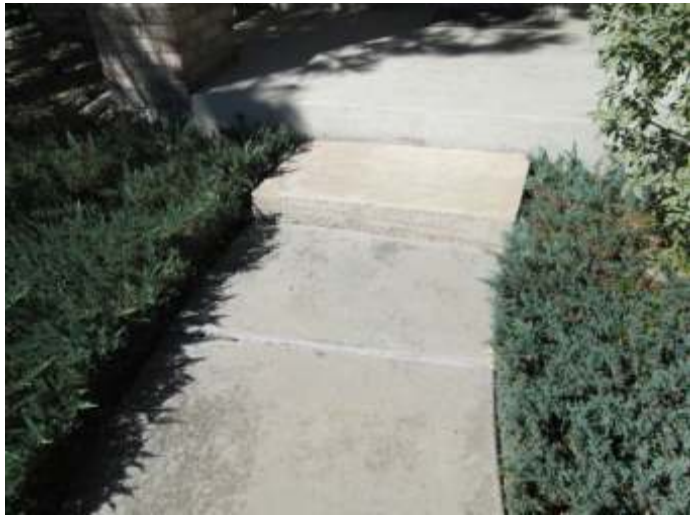
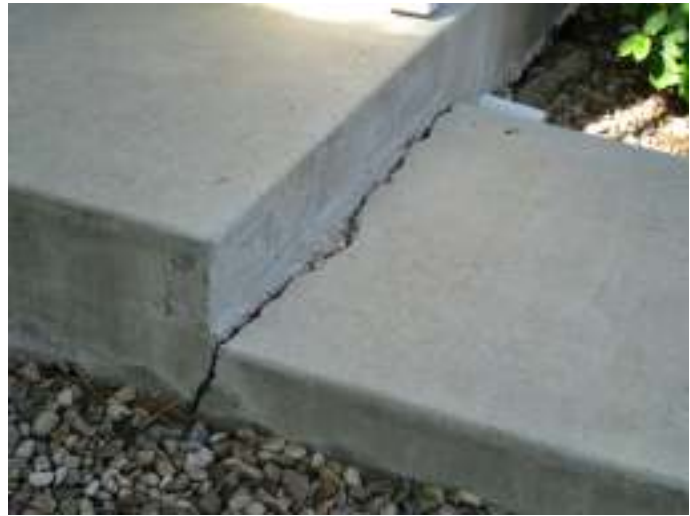
Comp #: 601 Concrete Sidewalks/Decks - Repair

Reported \$2,000 is budgeted each year for concrete repairs. However, based on the total square footage of concrete (combined with sidewalks), we do not believe this is adequate for long term repairs for concrete. Therefore, we have included an allowance for periodic major repairs above and beyond what the association is already budgeting for in the operating account.

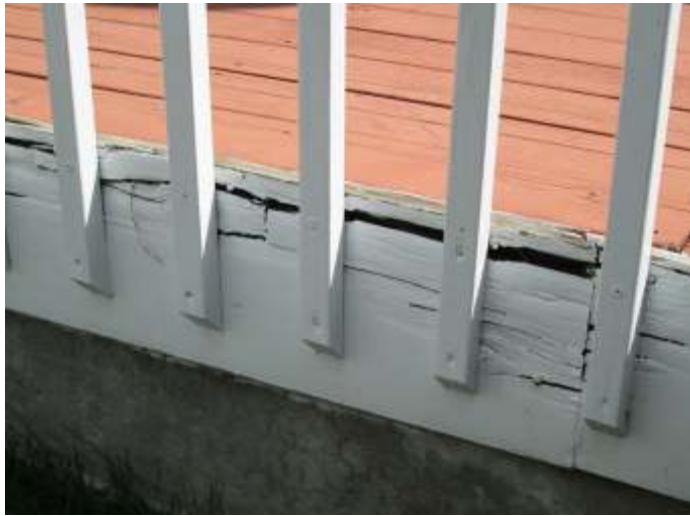
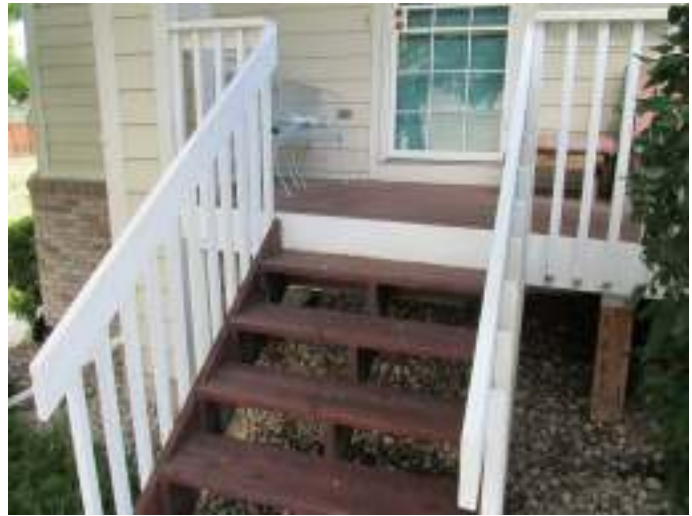
Comp #: 607 Unit Decks - Major Repairs/Replace

We noted several fascia boards that were rotted (unit 4043 & 4047). The deck for unit 4045 was recently stained and is in good condition. In general, conditions vary, which could mean that the owners have been taking their own initiative to maintain their own deck, or the association has been maintaining the decks in the worse condition. It was reported that these original decks are the responsibility of the association. Based on the observed condition, we suggest performing repairs prior to this next painting cycle.

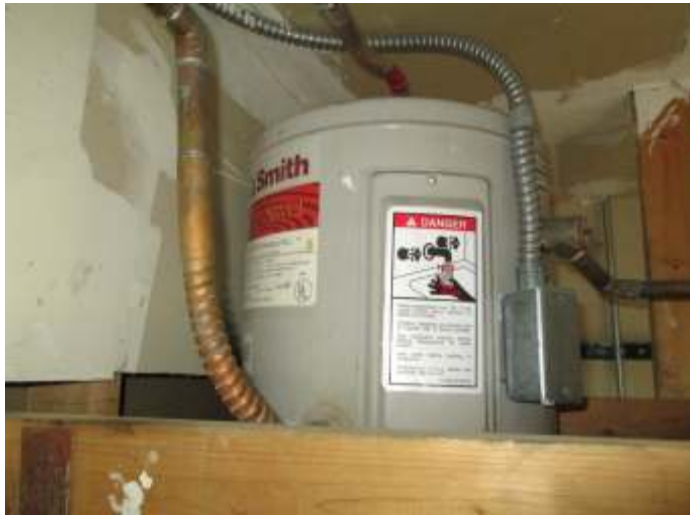
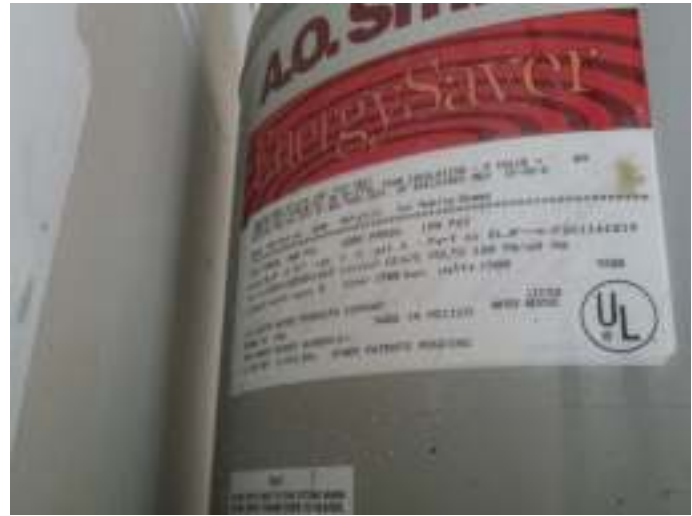
Comp #:    703    Hot Water Heater Tank - Replace

Heater is older, but appeared to be in good condition with no visible signs of rust or corrosion noted at the seams or connections. The replacement cost of this heater would be too small for separate Reserve designation. We suggest replacing this heater on an as needed basis with general operating dues.

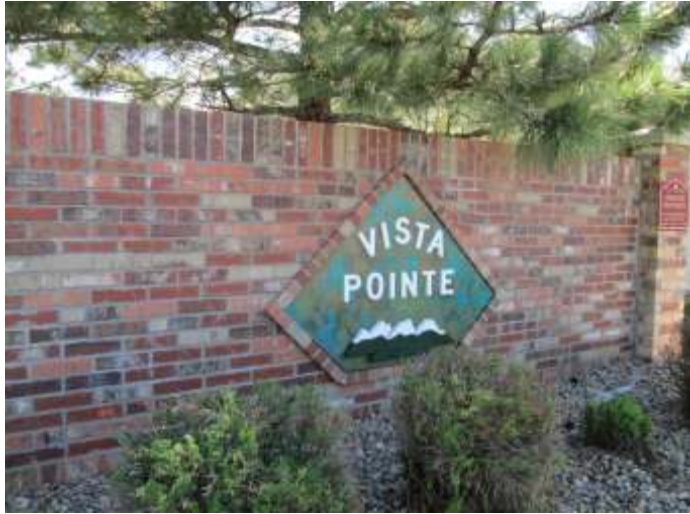
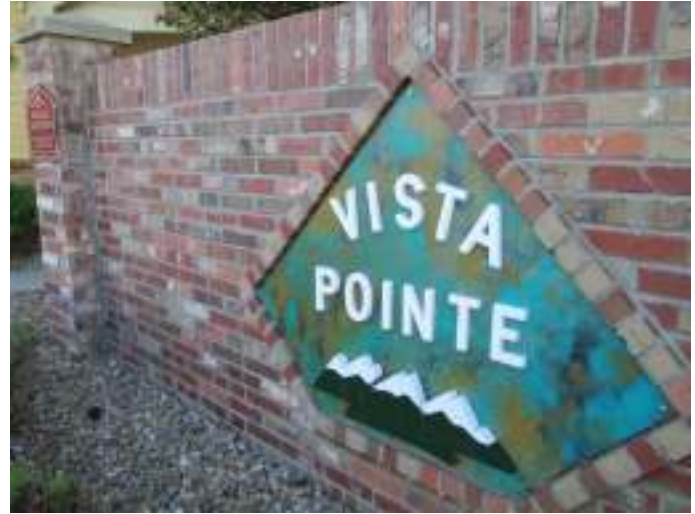
Comp #:    801    Monument - Rebuild

The Vista Pointe signs are inset into the brick wall that is included as part of another component. The replacement cost of the signs and lights is too small for separate Reserve designation. We recommend maintaining these and replacing the lights on an as needed basis with general operating funds.

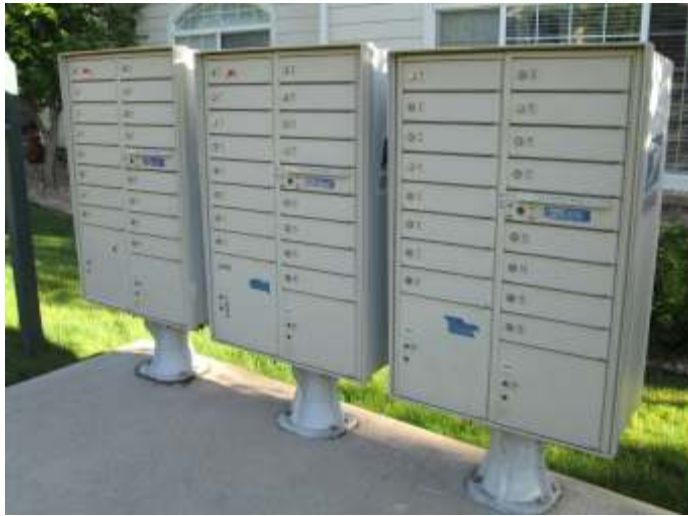
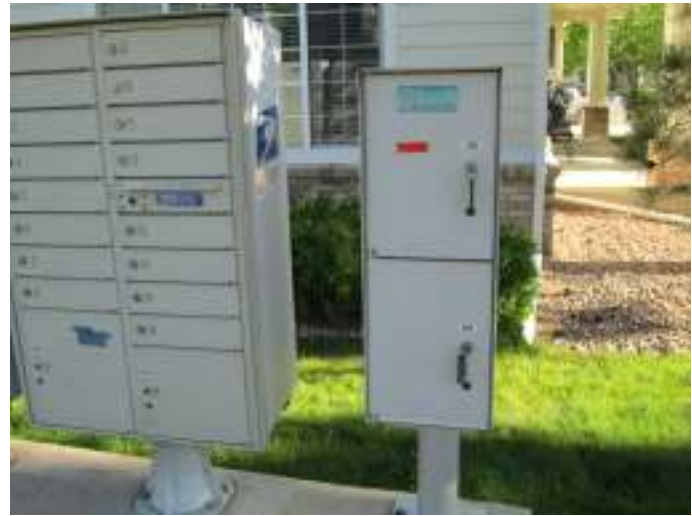
Comp #:    803    Mailboxes - Replace

No unusual conditions noted or reported at time of preparing this study. While the boxes may appear to be in good condition from an exterior appearance, often the seals deteriorate causing water to intrude into the boxes. According to several manufacturers, the typical life expectancy for this type of mailbox is 15 - 20 years in this environment. Remaining life is based on average age of all units. While it is possible the US Post Office will maintain and replace these boxes in the future, in our experience, we have seen in numerous similar circumstances that the post office makes the association responsible for replacement. This line item is included as a conservative measure in case the post office decides the association is responsible for replacement.

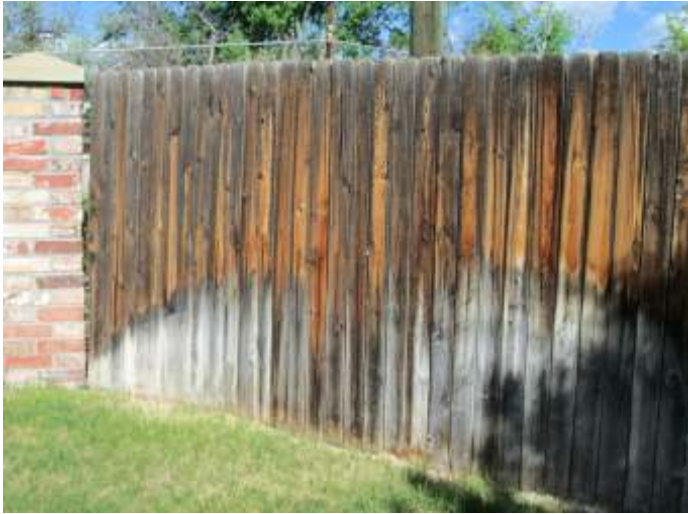
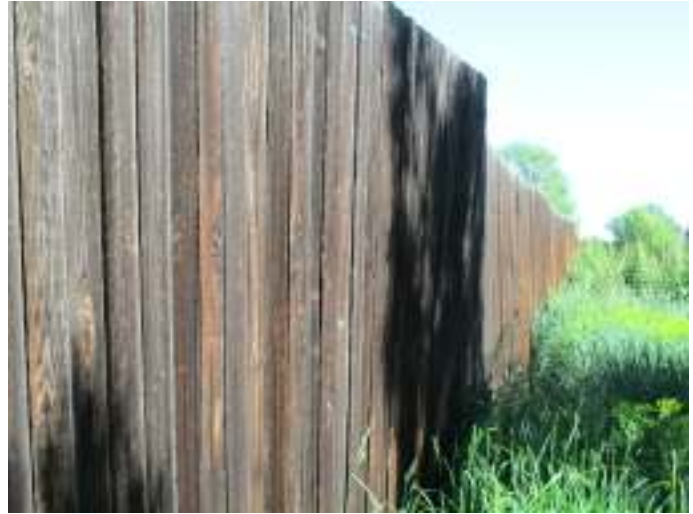
Comp #: 1001 Wood Fencing - Replace

This fence is showing typical signs of aging and minor deterioration with a few split and cracked slats noted. It does not appear this fence has been stained in the past. The replacement cycle is based on the observed quality of fence installed and the current condition. The fence is currently not stained, so the replacement cycle is shortened to reflect the expected effects the elements will have on exposed materials.

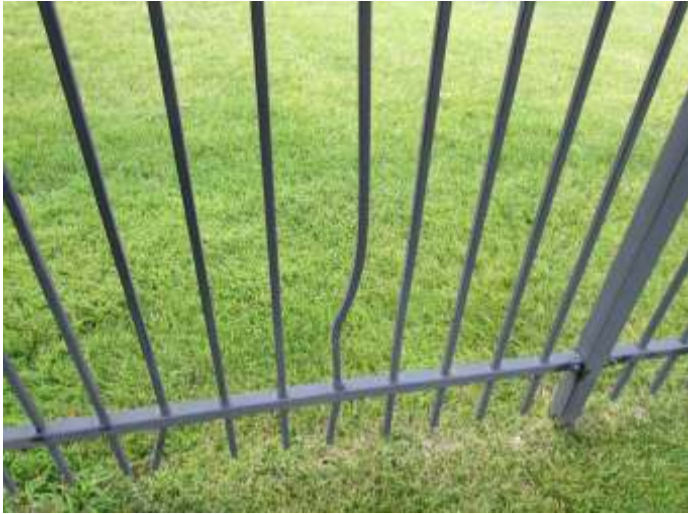
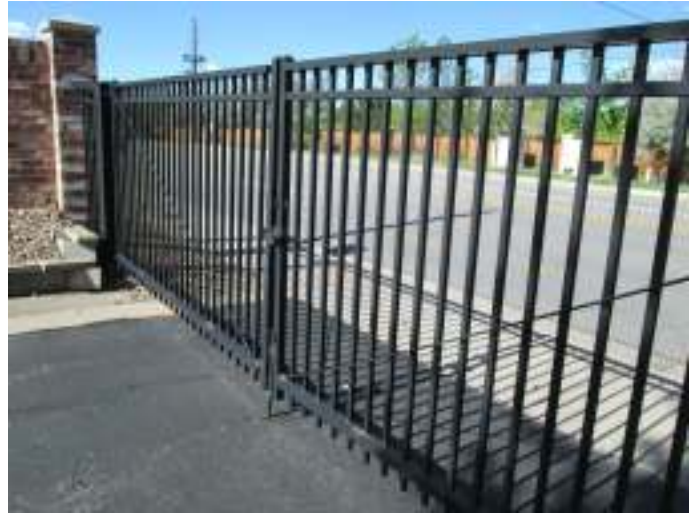
Comp #: 1002 Ironwork Fencing - Replace

One of the pickets on the pool fence was bent, probably due to someone trying to jump the fence at some time. This is not effecting the structural integrity of the fence. The emergency gate and handrails were in good condition with no significant signs of deterioration.

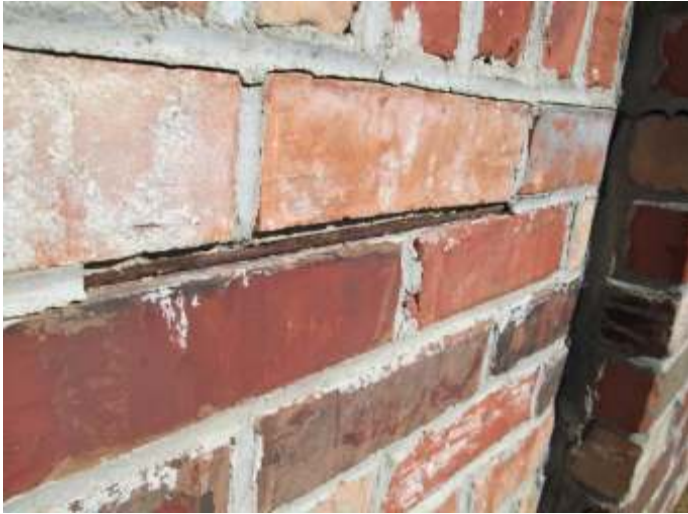
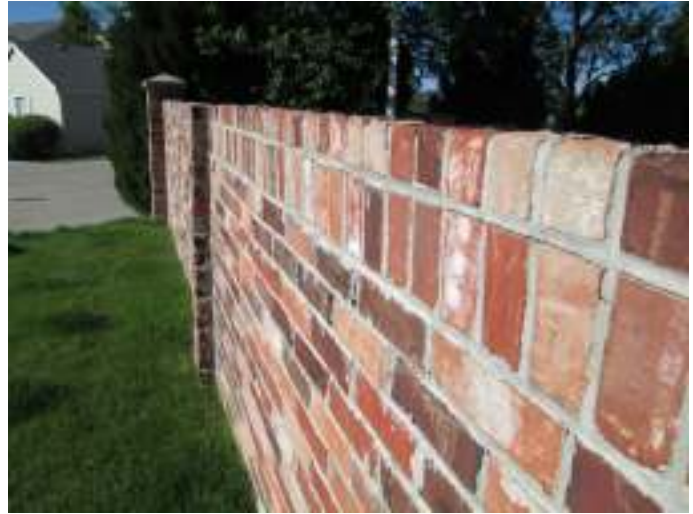
Comp #: 1005 Brick Wall - Replace (Old)

This section of the perimeter wall was not replaced and is in poor condition with noted instability and loose grout as well. There were a few sections where the metal support plate was showing through the grout. Based on the observed conditions and the fact that the other section of the wall had to be replaced, which was made from the same materials, we recommend the association plan on replacing this wall in the near future. Assume similar quality will be installed that will provide the association with a 75 year warranty. Therefore, future Reserve funding is not required and this is the reason for setting a 99 year life expectancy.

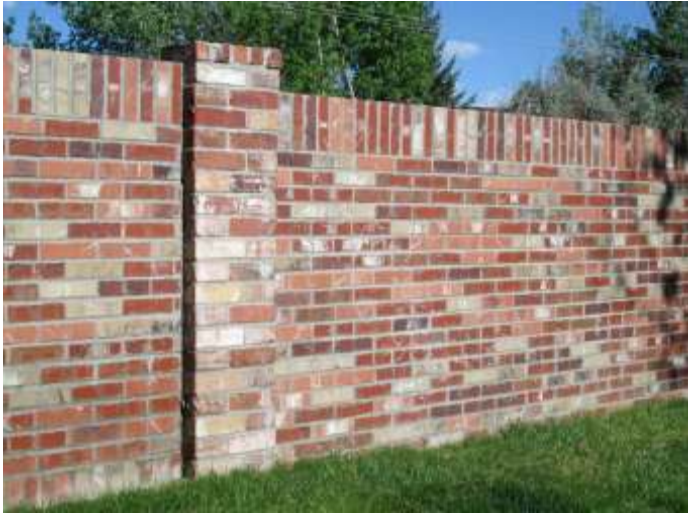
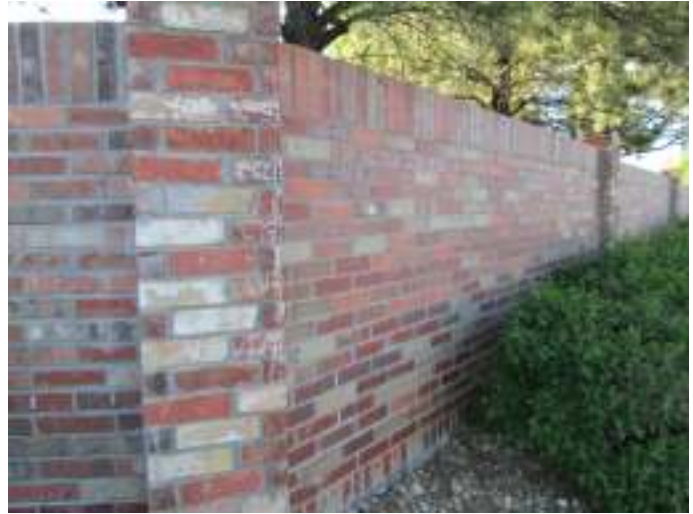
Comp #: 1005 Brick Wall - Replace (New)

This section of the perimeter wall was completely replaced and was reported to be guaranteed for 75 years. As a result, Reserve funding is not currently required for this component. If conditions change in the future, Reserve funding can be added in future report updates.

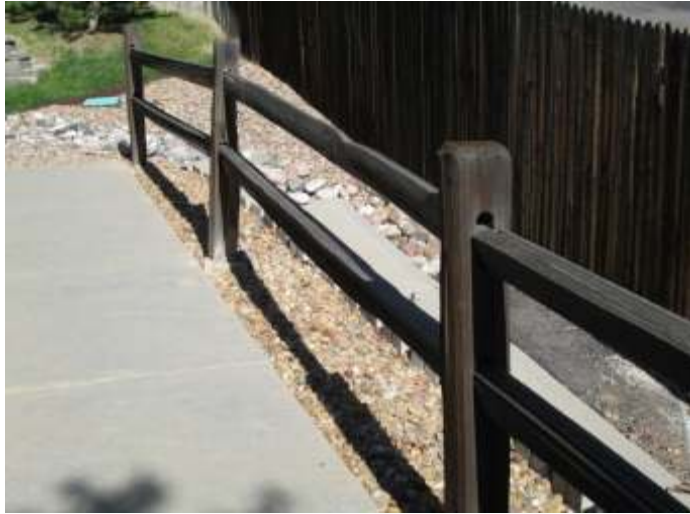
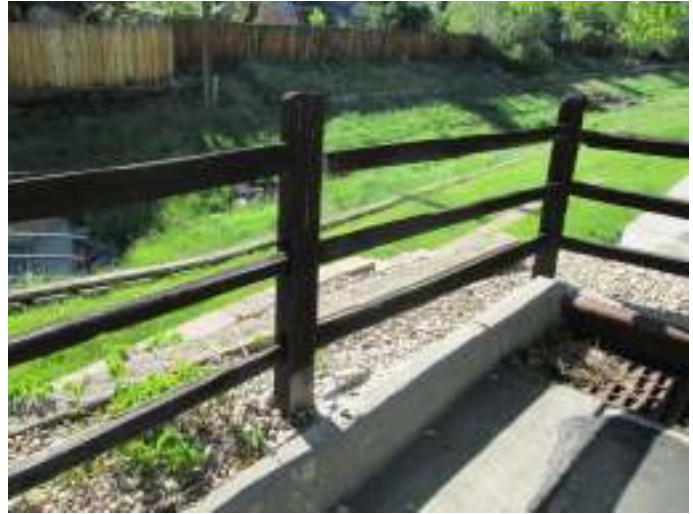
Comp #:    1009    Split Rail Fencing - Replace

Fencing is in fair condition and has the weathered and authentic appearance this fence is supposed to have. No signs of broken or splintered rails or posts were observed at the time of inspection. Due to the small area, we suggest replacing broken rails and posts on an as needed basis with general operating funds. Therefore, at this time, separate Reserve funding is not required for this component.

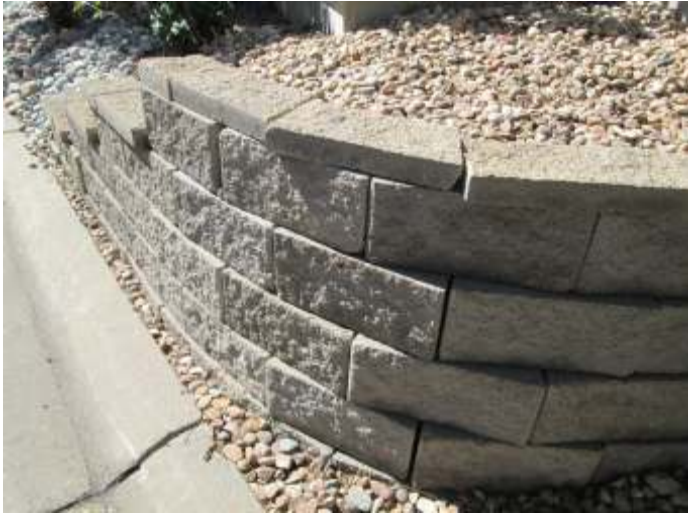
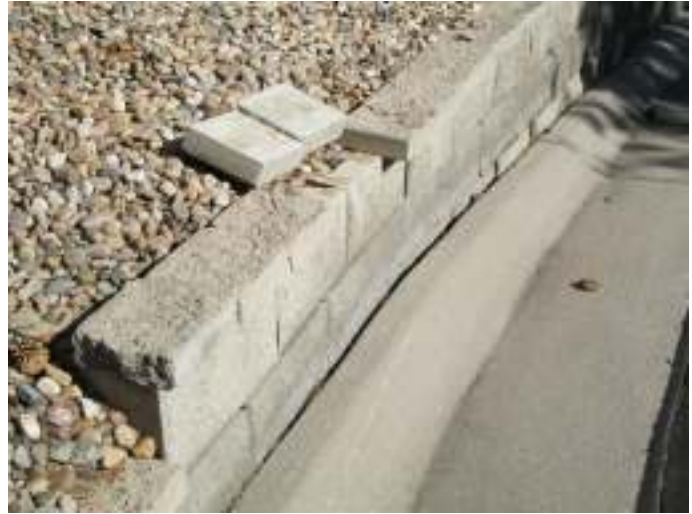
Comp #: 1011 Retaining Wall - Replace

A few loose caps were noted, but there was no evidence of any leaning or structural concerns noted. While these walls are designed to have an indefinite life expectancy, there are times where shifting and settling grounds cause a wall to shift as well. Due to the amount of walls on the property, we have included an allowance for periodic repairs and partial replacement. If the history of repairs do not meet our expectations, then the useful life can be adjusted in future Reserve Study updates.

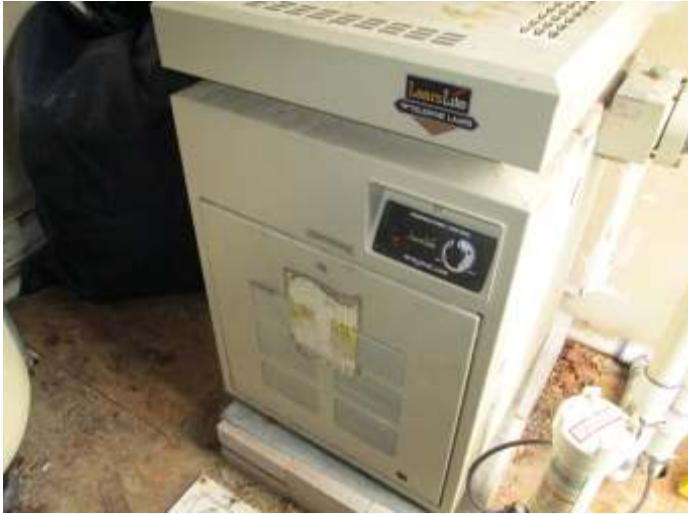
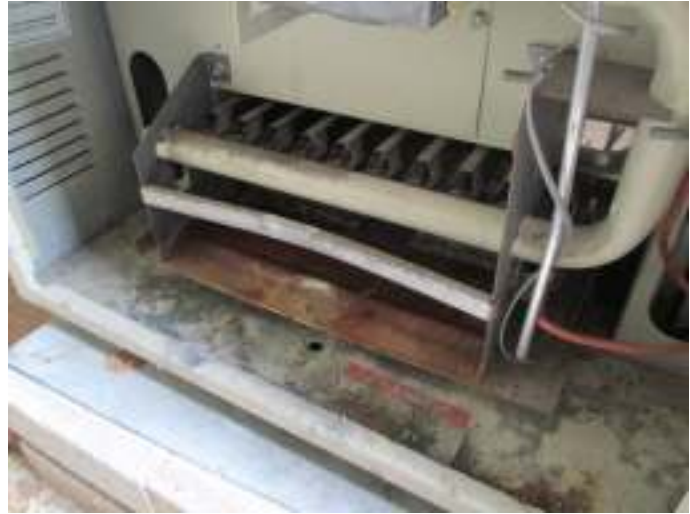
Comp #: 1104 Pool Heater - Replace

Current conditions exhibit significant rusting on plate under burners. There was also a strong gas scent at time of field evaluation. The average life expectancy for pool heaters range between 10 - 15 years. Based on the age of the heater, it has reached the end of the normal life expectancy. Therefore, we recommend the association plan for replacement at any time in the near future. Cost reflects the percentage responsibility of 47% of the all replacement costs associated with the pool area.

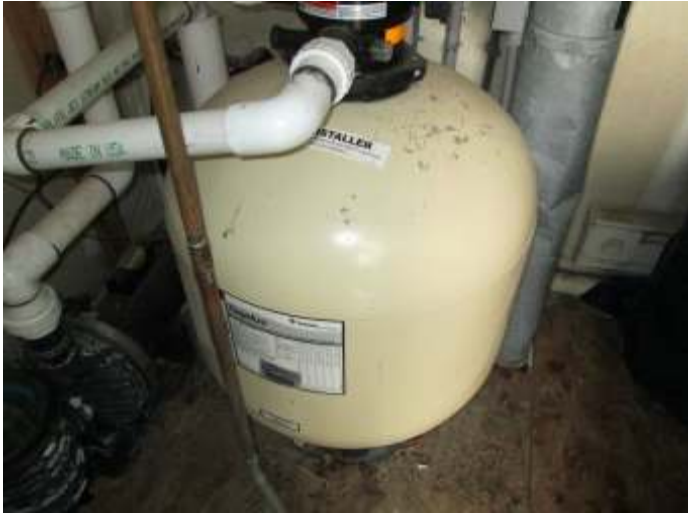
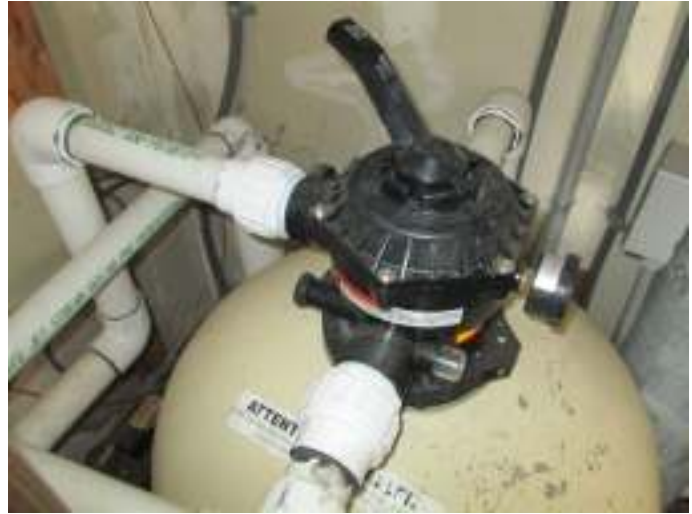
Comp #: 1107 Pool Filter - Replace

Filter was replaced in 2011 and there are no current unusual conditions visible. The average life expectancy of pool filters ranges from 12 - 15 years, depending on quality of tank and level of maintenance. Cost reflects the percentage responsibility of 47% of the all replacement costs associated with the pool area.

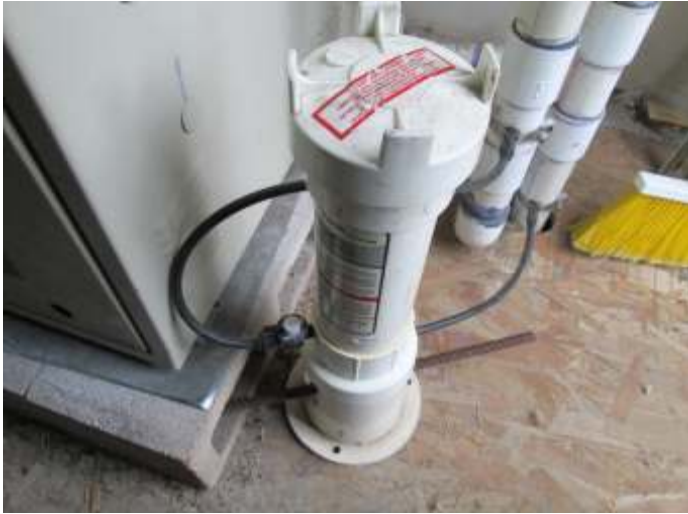
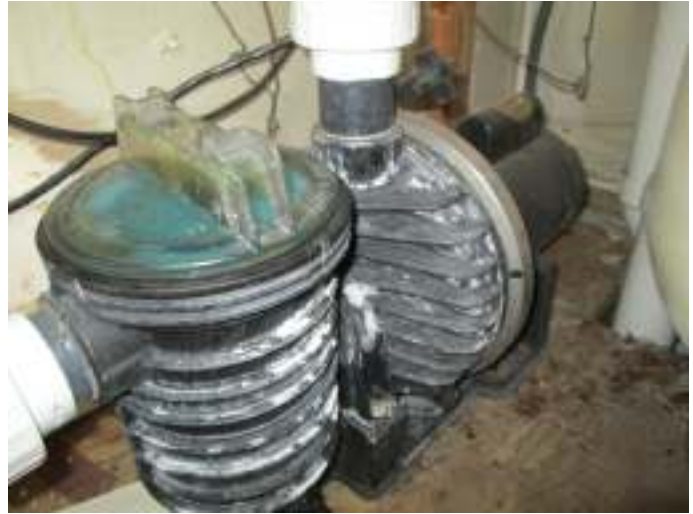
Comp #: 1110 Misc. Pool Equipment - Replace

No unusual conditions noted or reported at time of field evaluation. Pumps and motors can be rebuilt as opposed to being completely replaced to extend the life expectancy of the unit. The replacement cost of the tab feeder chlorinator unit is too small (less than \$300) for Reserve designation. Replace these items as needed with general operating funds.

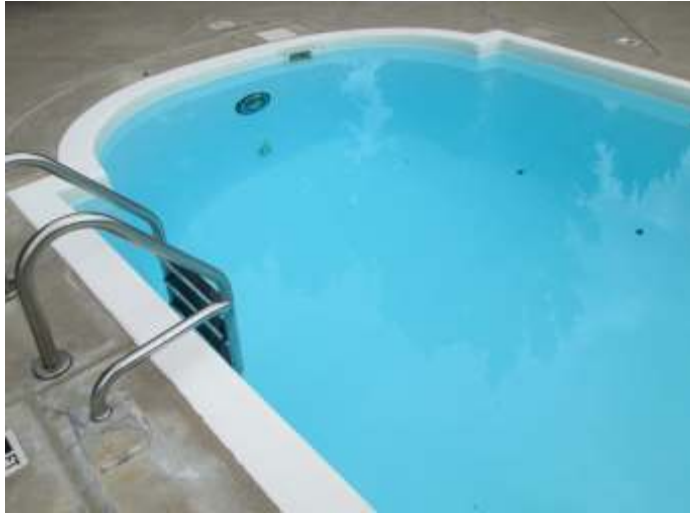
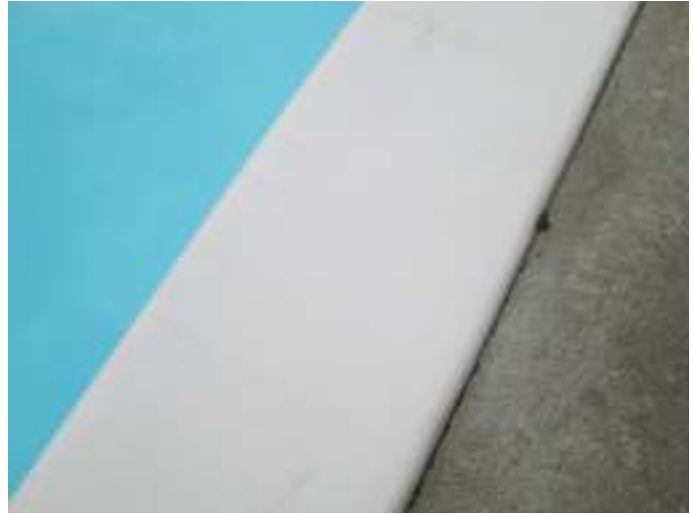
Comp #:    1115    Acrylic Pool - Resurface

The depth of the pool ranges from 3 - 5 feet deep. Reported that a permit was not pulled at time of installation. At time of installation, the hole was dug, sand was placed inside the hole, then the pool was inserted. According to a local contractor, this is typical protocol for installation of an acrylic pool. According to the manufacturer, as long as installation complied with specifications, then the pool shell has a lifetime warranty against defects and blemishes. However, in our experience, we have also seen the need to recoat the surface. This involves sanding the surface and applying a new gel coat onto the pool shell. Due to the minor cracking noted on the surface, we recommend this gets addressed in the near future.

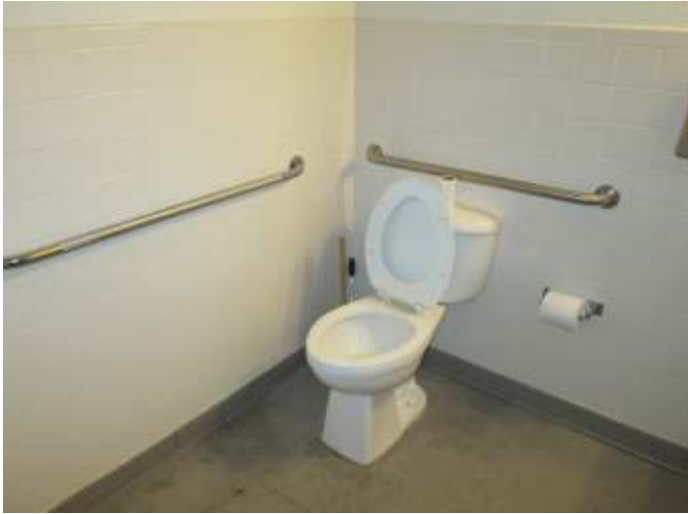
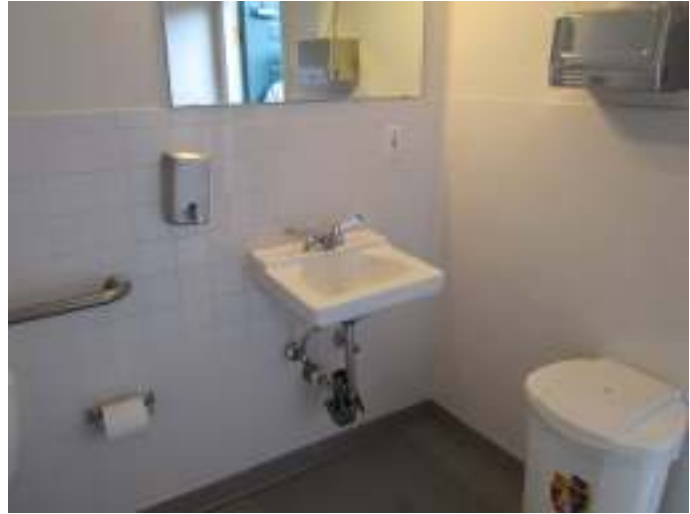
Comp #: 1413 Restroom - Remodel

Most associations perform a general remodel of the restroom/locker room interiors every 15 - 20 years to maintain appearance and keep up with current decorative trends. Based on the age of the community and the observed conditions, we suggest planning a remodel of the interiors within the next 5 - 8 years. The final decision is up to the community members in deciding when to spend the money to perform this project since it is considered cosmetic.
