**Vista Pointe Townhome Association  
4007 E. Geddes Circle  
Centennial, CO 80122**

**Level 1 Reserve Analysis**

**Report Period – 01/01/14 – 12/31/14**

**Client Reference Number - 8682  
Property Type – Townhomes  
Number of Units – 47  
Fiscal Year End – December 31**

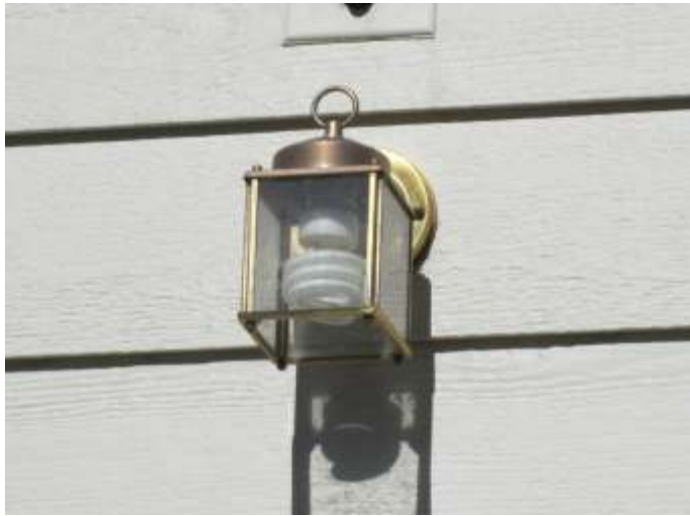
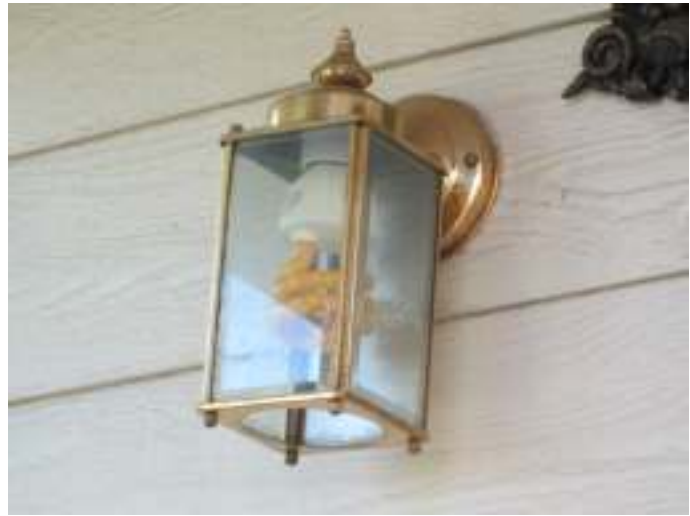
Comp #: 1602 Exterior Wall Mount - Replace

Lights are older No unusual conditions were observed or reported at time of observation. While replacement can occur on an as needed basis, it is our opinion and recommendation to replace all lights at the same time every 15 - 20 years to maintain a consistent appearance throughout the property. In addition, by replacing multiple fixtures, the association will be able to obtain a quantity discount for the fixtures. Estimated replacement cost includes labor for installation. Remaining life based on observed conditions and age.

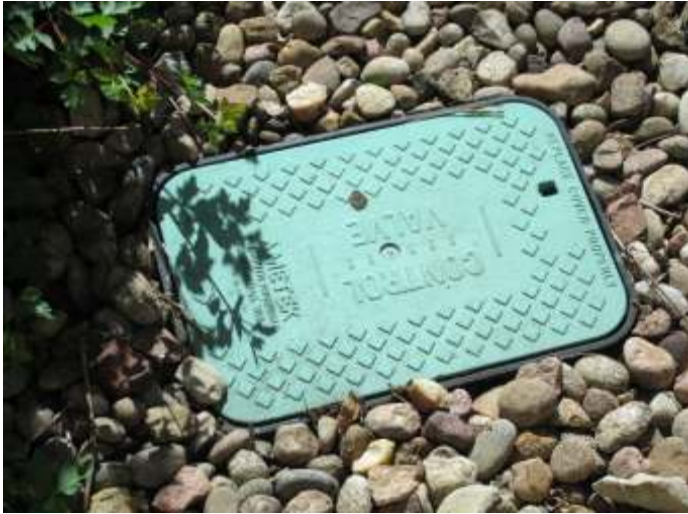
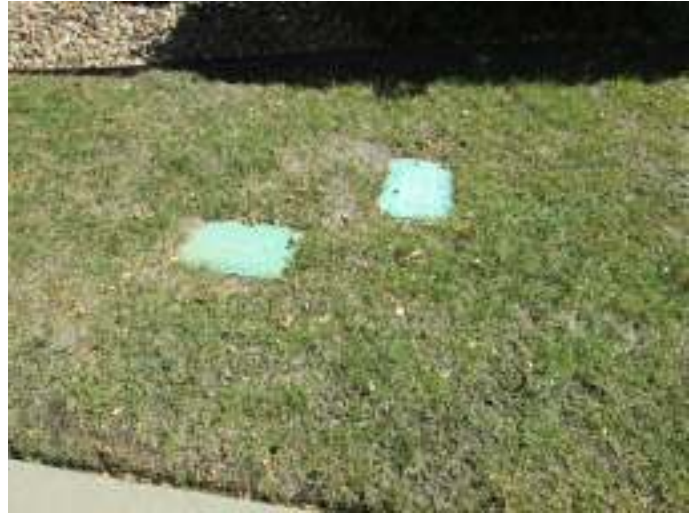
Comp #: 1701 Irrigation System - Rebuild

Irrigation system appears to be functional and in good condition with no visible problems noted during field evaluation. The materials used during construction should have a long life expectancy with proper maintenance. This system is over 10 years old, and in our experience, systems that reach 20 years old start to see the need for major renovations and repairs. Therefore, we suggest the association establish a Reserve allowance for major repairs every 10 years. The remaining life is based on the age of the system and when it will reach the age that major repairs will be required.

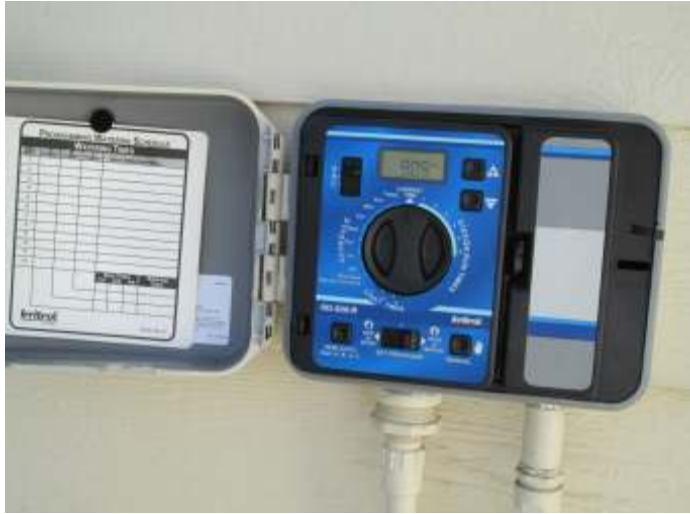
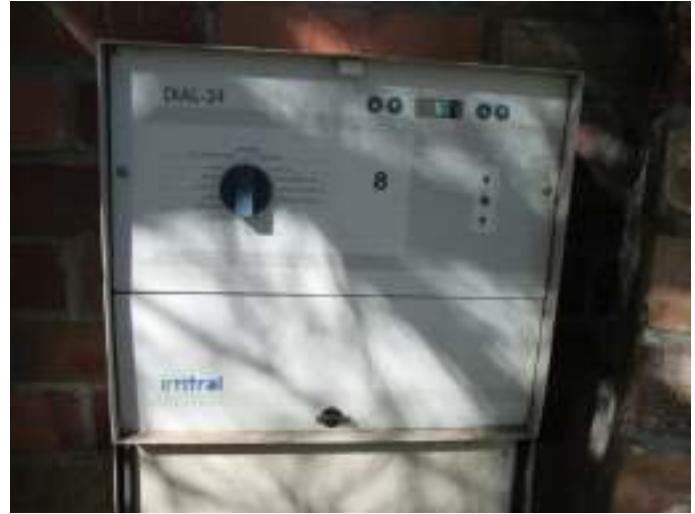
Comp #: 1703 Irrigation Timeclocks - Replace

Under normal conditions (not including Acts of God, vandalism, etc.) these clocks should last 10 - 12 years with proper maintenance. Due to advances in technology and water efficiency, we suggest reserving to replace all clocks at the same time. A lot of communities are upgrading to ET type controllers and the costs reflect this. Remaining useful life based on average age of all clocks.

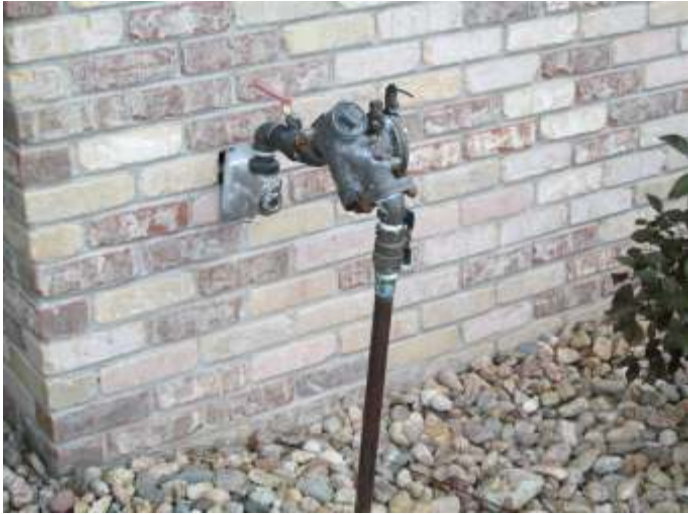
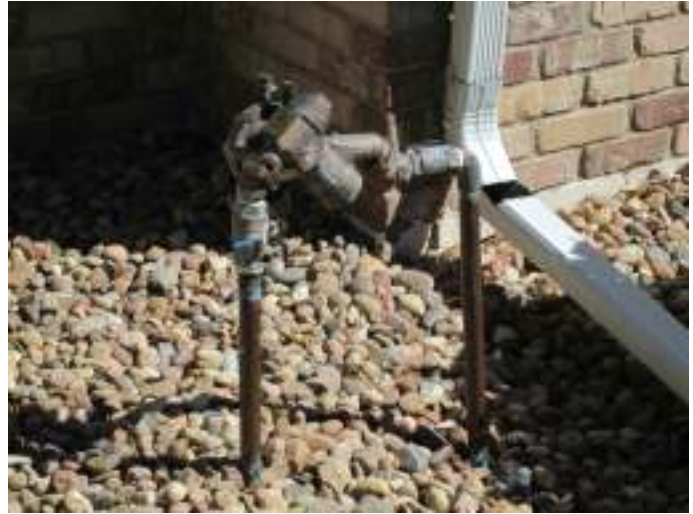
Comp #:    1706   Backflow Devices - Replace

No problems noted at the time of inspection. Due to the minimal replacement cost (\$500 - \$800 each) and unpredictable useful life associated with this component, reserve funding is not appropriate. Make repairs and replacements as necessary as an operating expense.

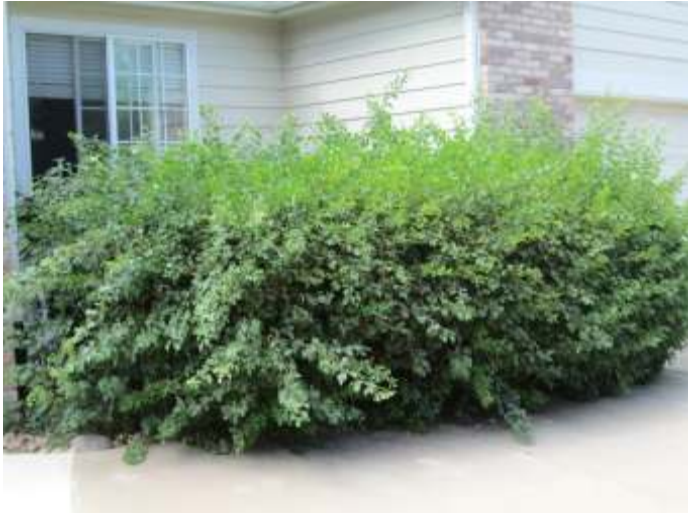
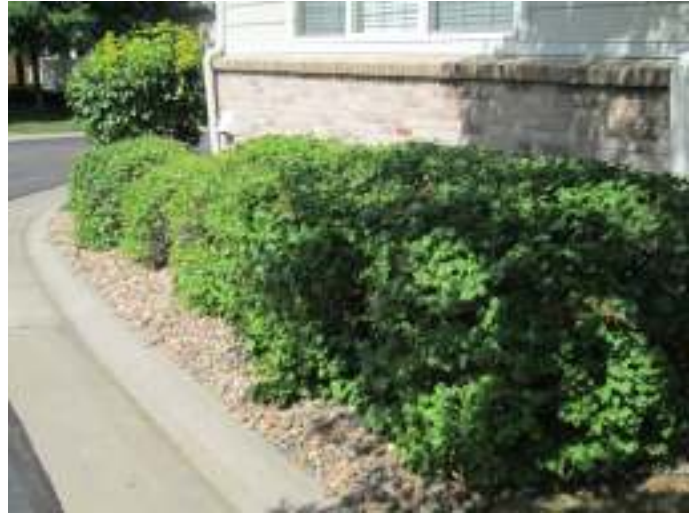
Comp #:    1801    Groundcover - Replenish

Typically, associations will establish a line item in the operating budget to handle annual replacement of shrubs, plants, grass areas, etc. Therefore, separate Reserve funding is not necessary as long as funding has been established in a separate budget. If the association prefers to include a funding allowance for groundcover replenishment, then we would need to know how much and how often the current board of directors would prefer to set aside since this would be considered a discretionary expense.
